**INTERSTATE 29 NORTHBOUND  
BRIDGE over the  
PERRY CREEK CONDUIT**

**SIOUX CITY, IOWA**

**FIRE DAMAGE INSPECTION  
REPORT**

**NOVEMBER 2, 2019**

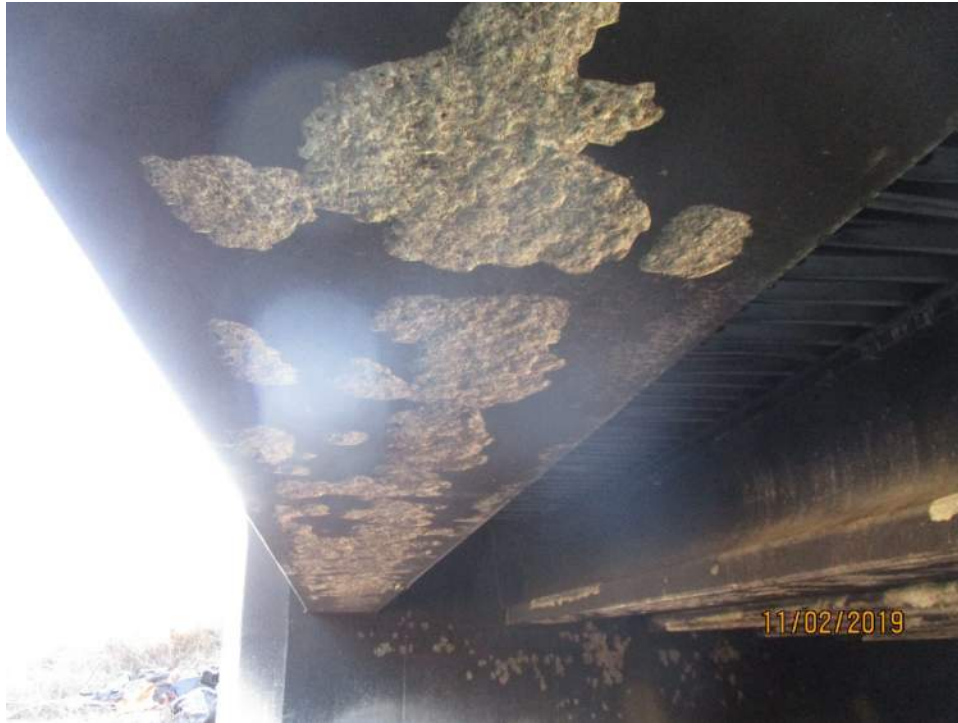
- Beam “H” was observed to have minor bottom flange spalling along the south half of the girder.
- Sounding indicated delaminated concrete along the top edge of the bottom flange for the same length.
- Remaining camber was visually approximated to be between ½” to 1”.

*Photo 001: Bottom Flange – Beam "H"*

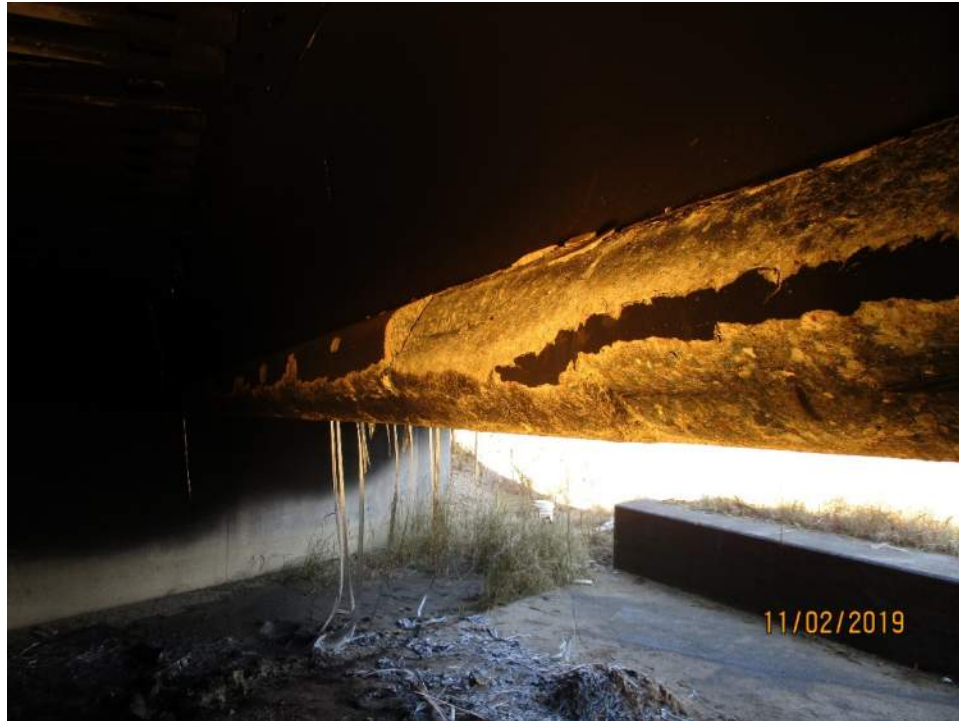
- Beam “G” was observed to have bottom flange spalling and delaminated concrete.
- The bottom exterior strand was exposed and soot stained at the south face of the beam.
- The top edge of the bottom flange had surface spalling on the north face of the beam.
- Remaining camber was visually approximated to be between ½” to 1”.

*Photo 003: Beam "G" – Bottom Flange Spalling*

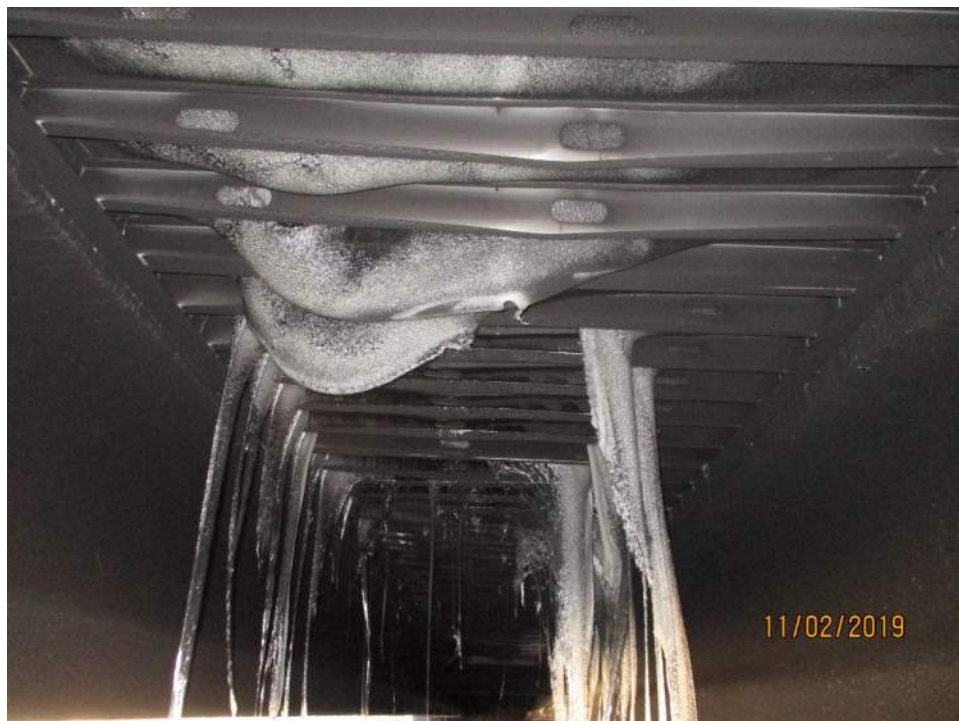
*Photo 004: Deck Soffit Between Beam "G" and Beam "H"*

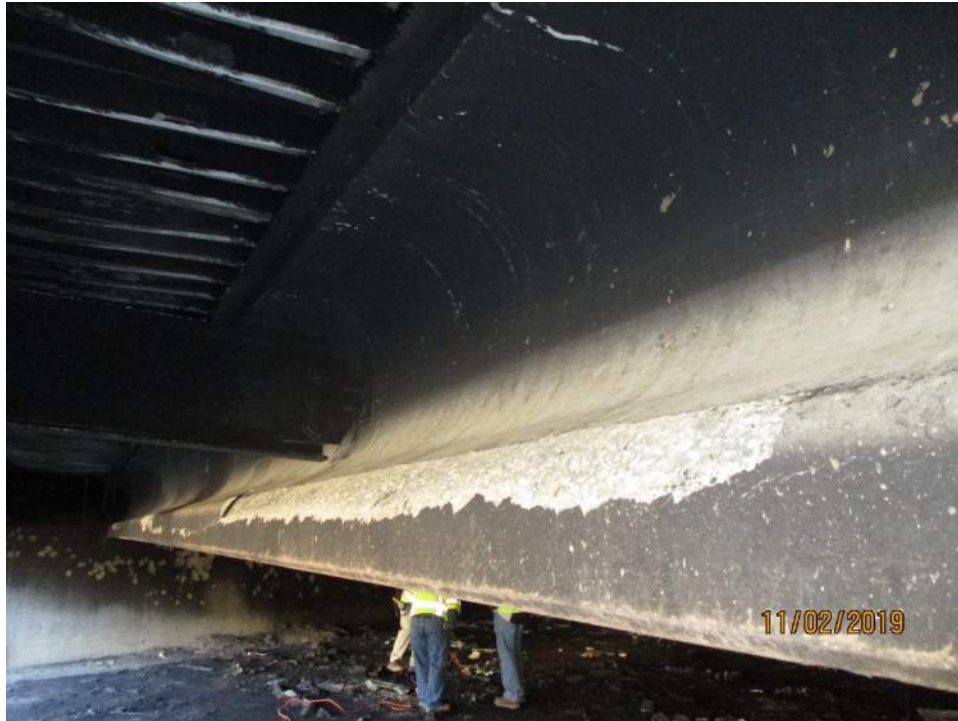
*Photo 005: Beam “G” – Flange Spalling*

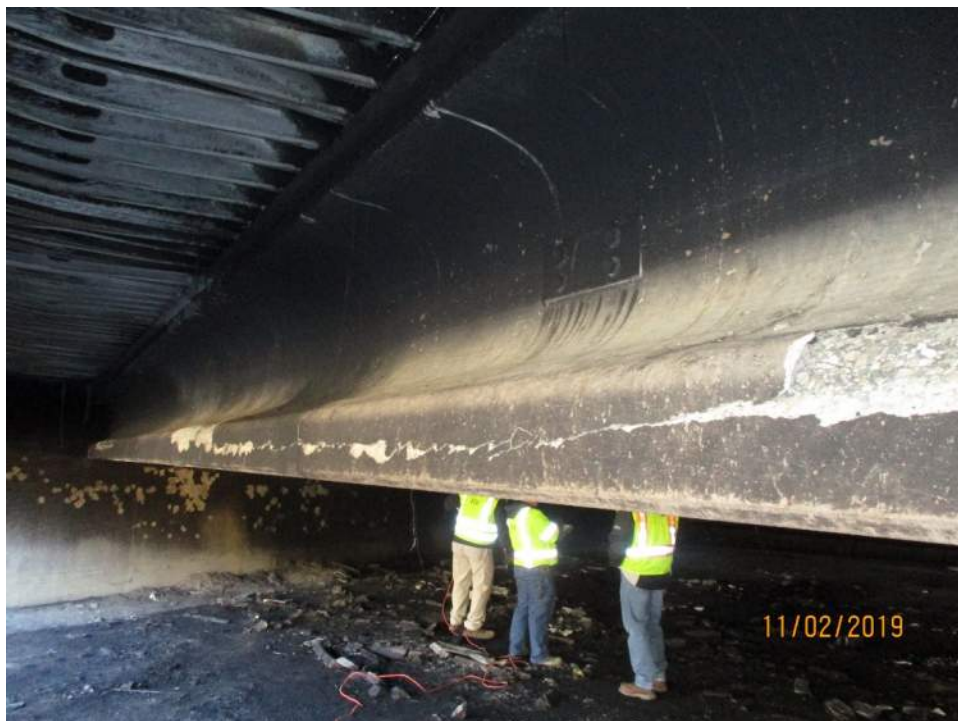
*Photo 006: Beam “G” – Bottom Flange Spalling*

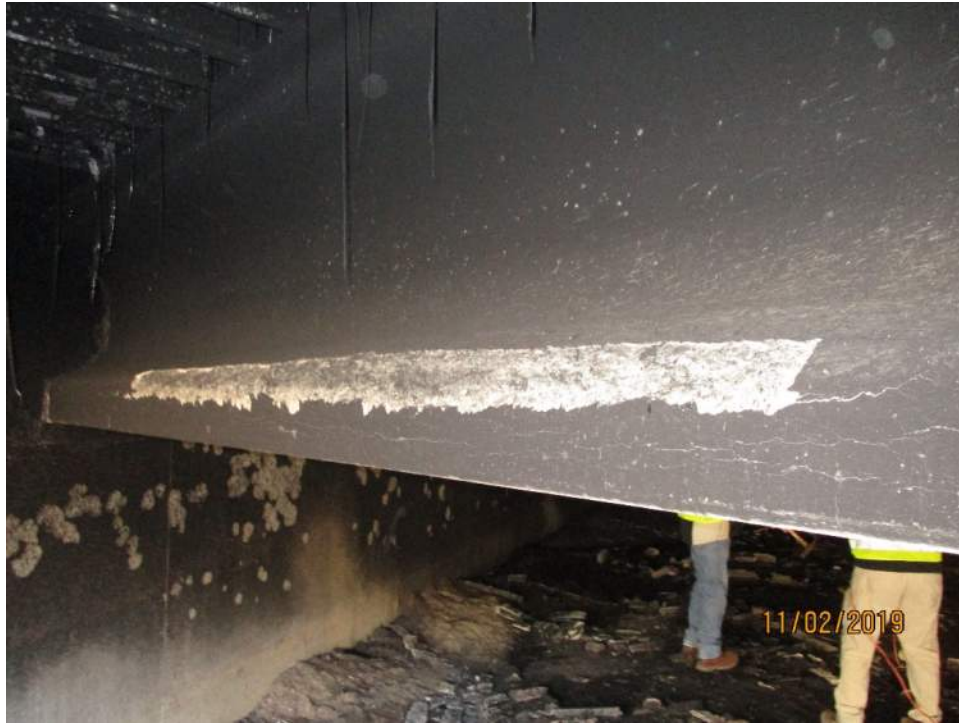
*Photo 007: Beam "G" – Bottom Flange Spalling*

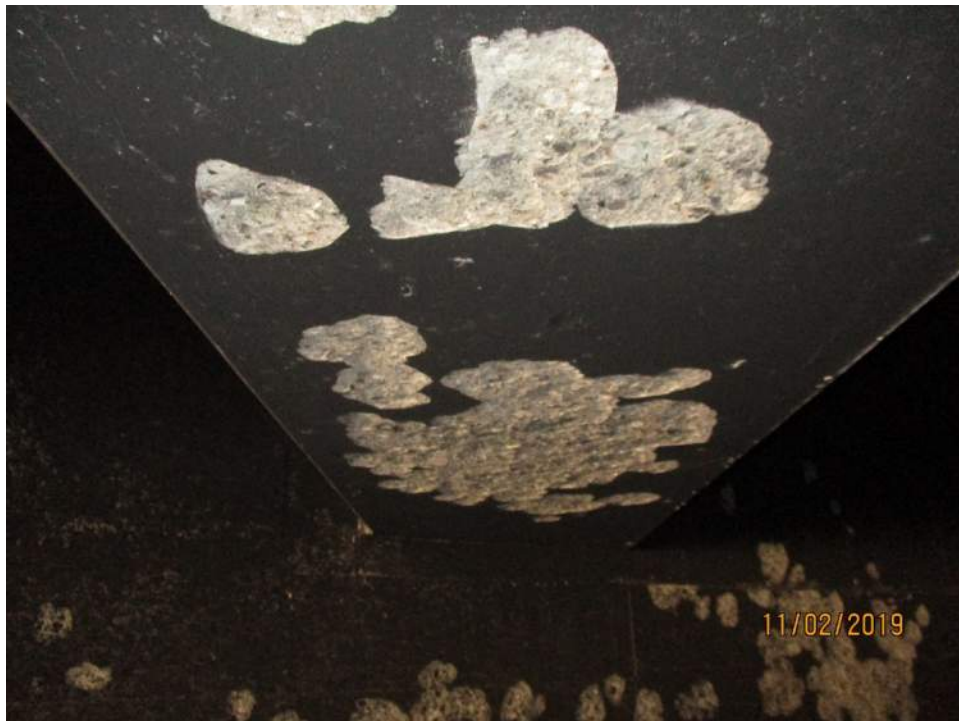
*Photo 008: Beam "G" – Bottom Flange Spalling*

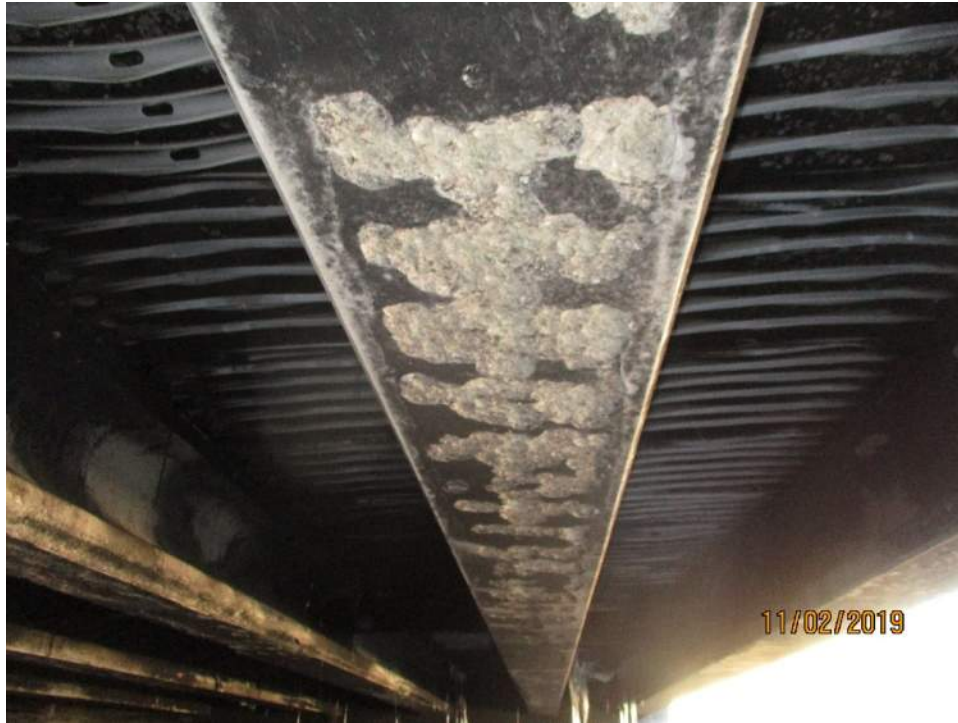
*Photo 009: Beam "G" – Bottom Flange Spalling*

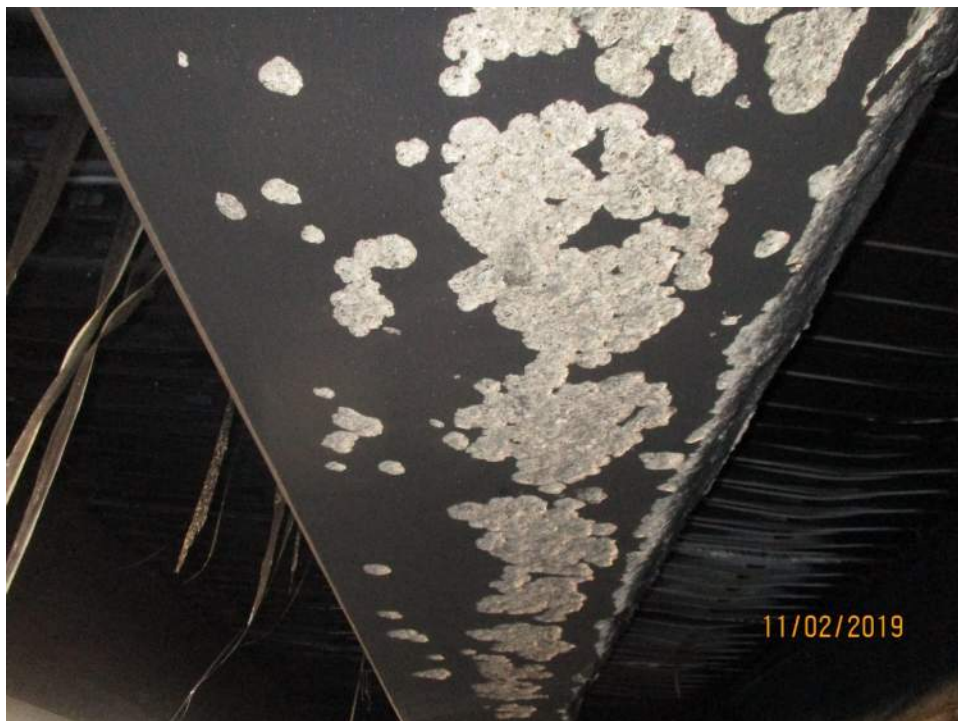
*Photo 010: Beam "G" – Bottom Flange Spalling*

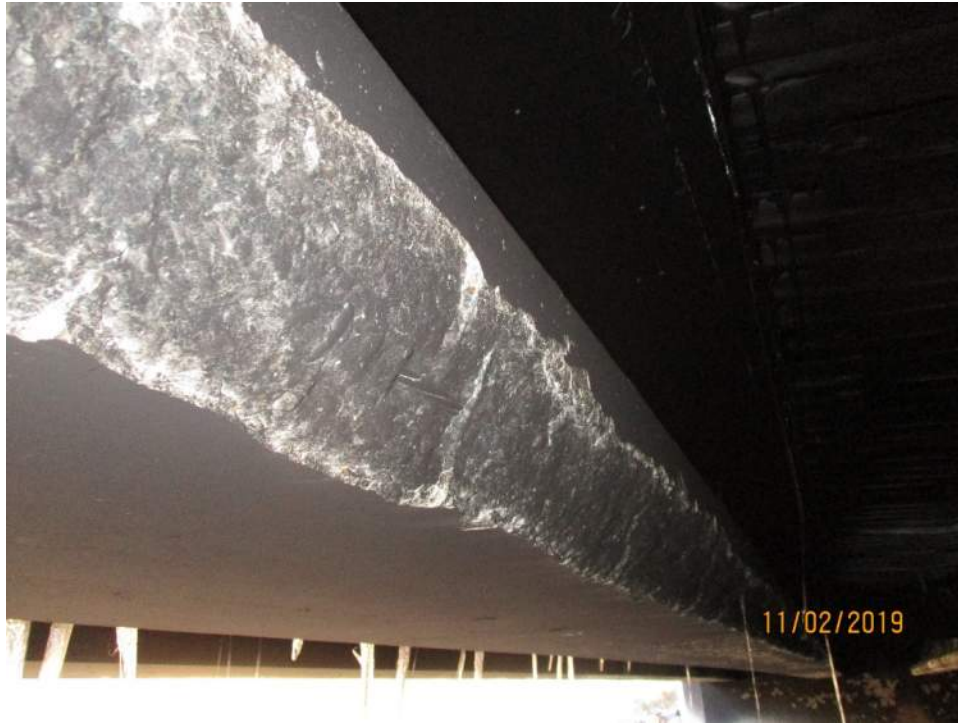
*Photo 011: Beam “G” – Flange Spalling, South Face*

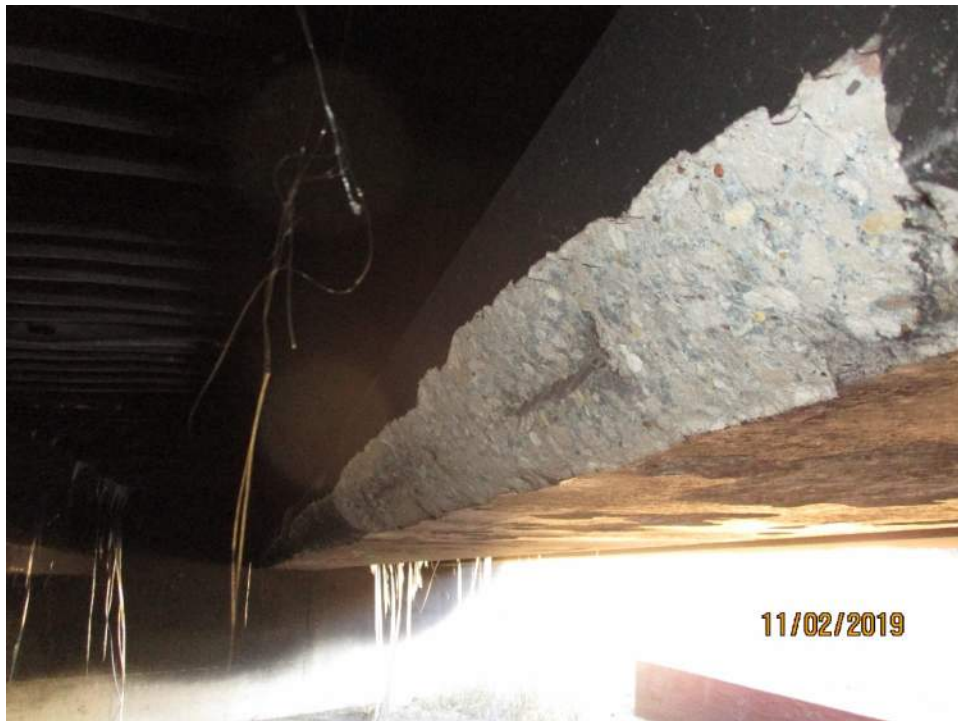
*Photo 012: Beam “G” – Flange Spalling, South Face*

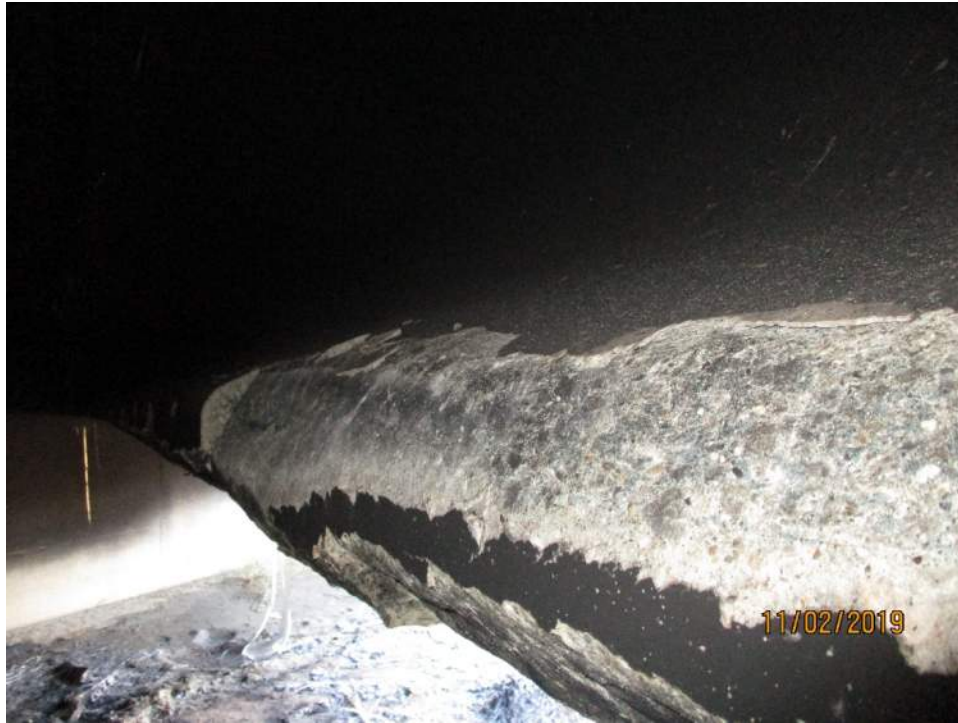
*Photo 013: Beam “G” – Flange Spalling, South Face*

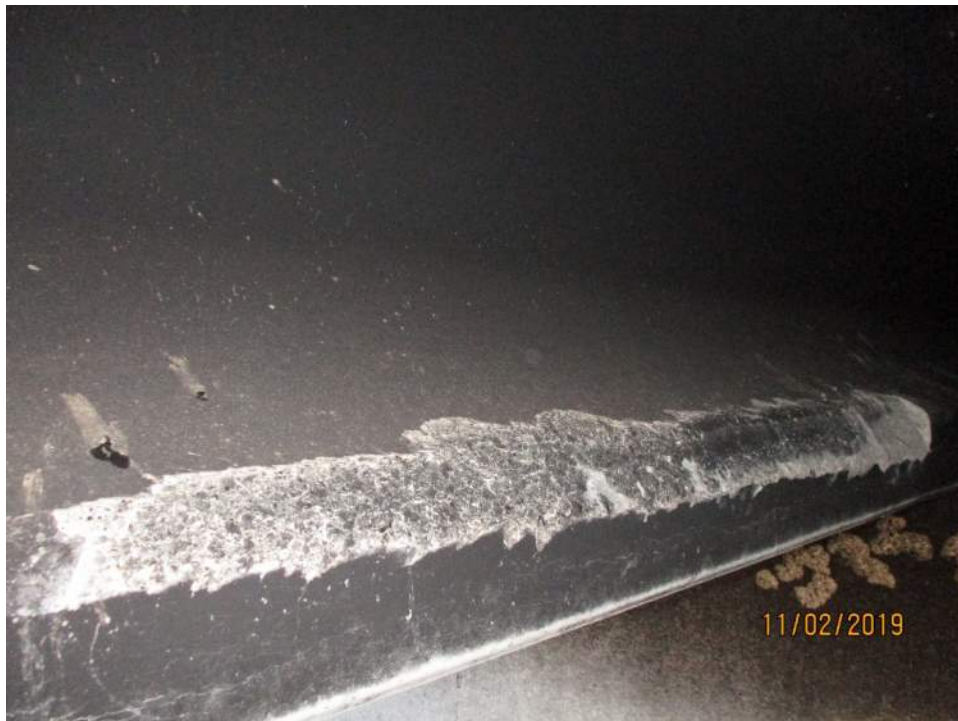
*Photo 014: Beam “G” – Bottom Flange Spalling, South Face*

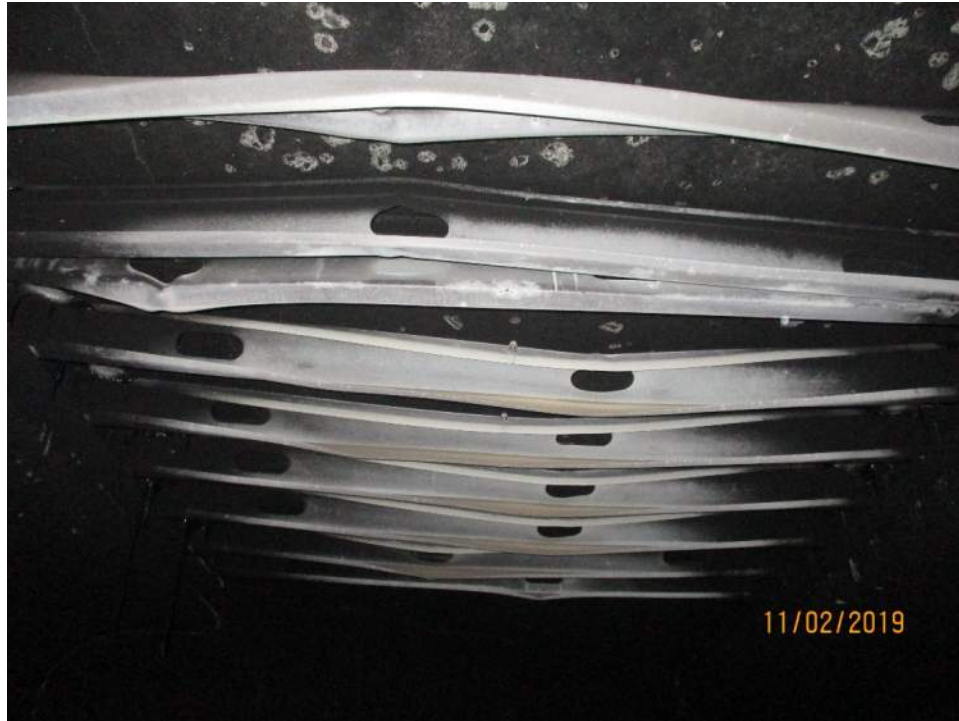
*Photo 015: Melted Formwork between Beam "G" and Beam "F"*

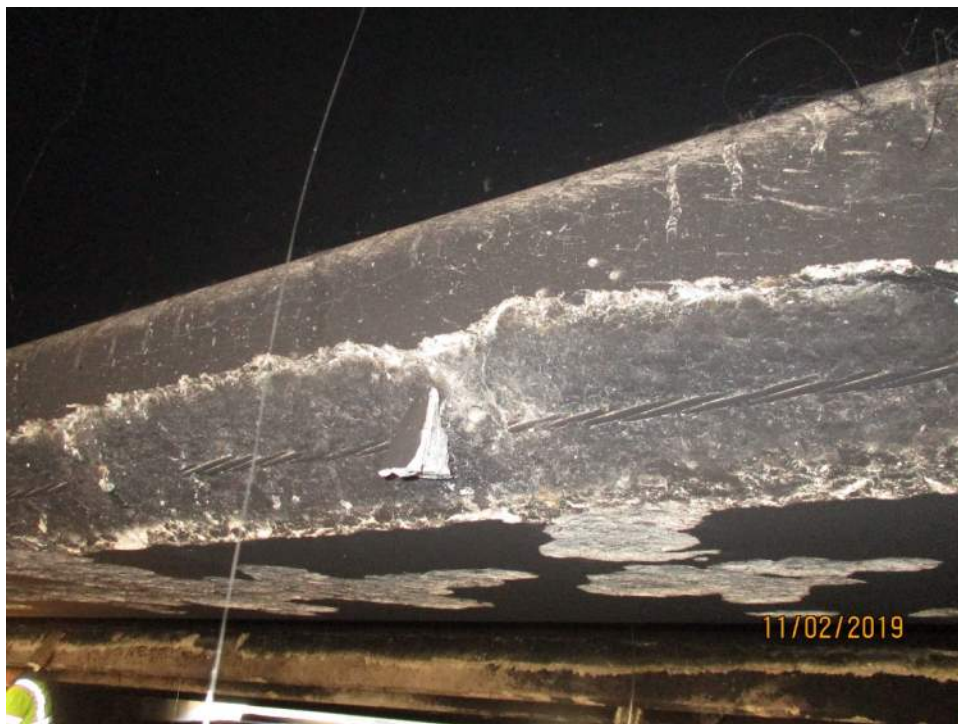
- Beams "D", "E", and "F" were observed to have extensive bottom flange spalling and delaminated concrete for the length of the beam.
  - Both exterior strands in the bottom layer of strands were exposed and soot stained the majority of the length of all three beams.

*Photo 018: Beam "F" – Bottom Flange Spalling and Exposed Strand, North Face*

1. Maintain traffic only between Beams “A” and “C” unless load testing is completed to verify the capacity of Beam “D”.
2. Replace damaged beams.

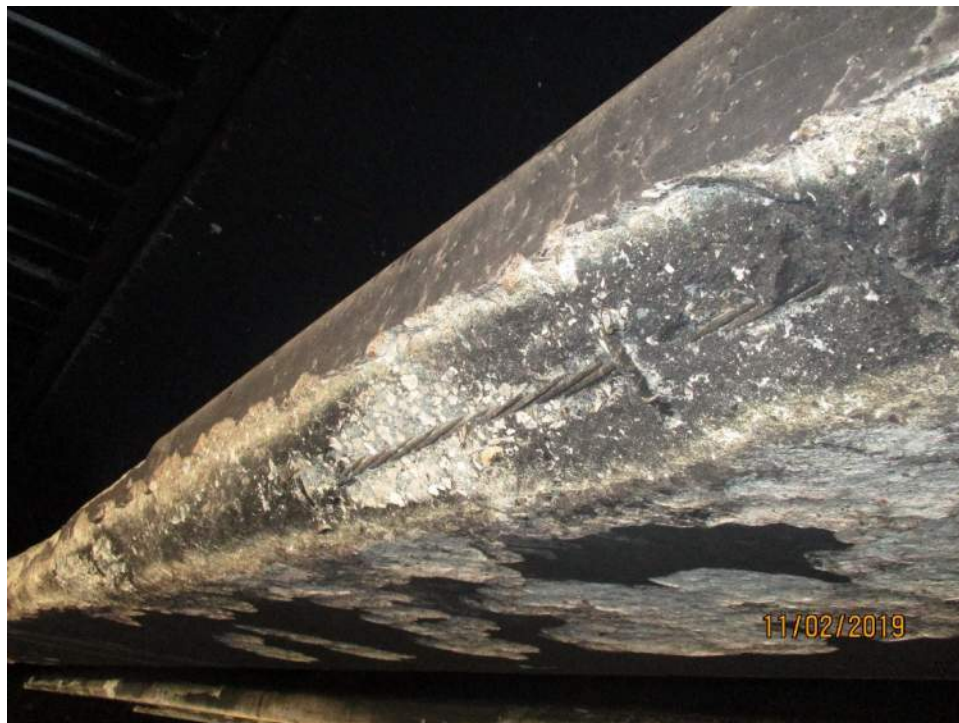
*Photo 019: Beam “F” – Bottom Flange Spall and Exposed Strand, North Face*

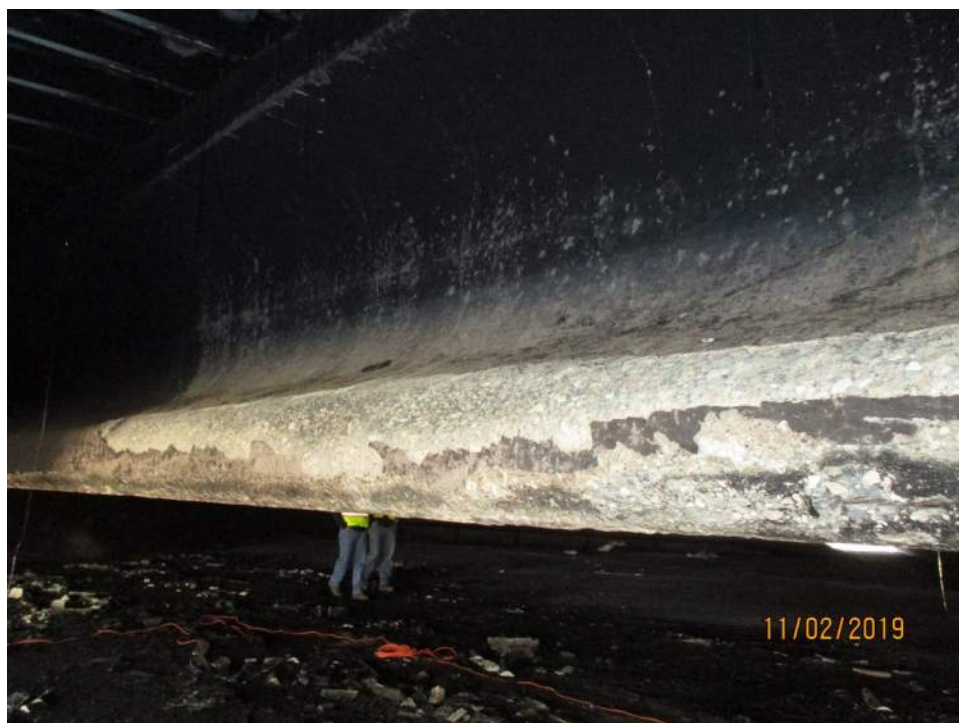
*Photo 020: Beam “F” – Bottom Flange Spall, North Face*

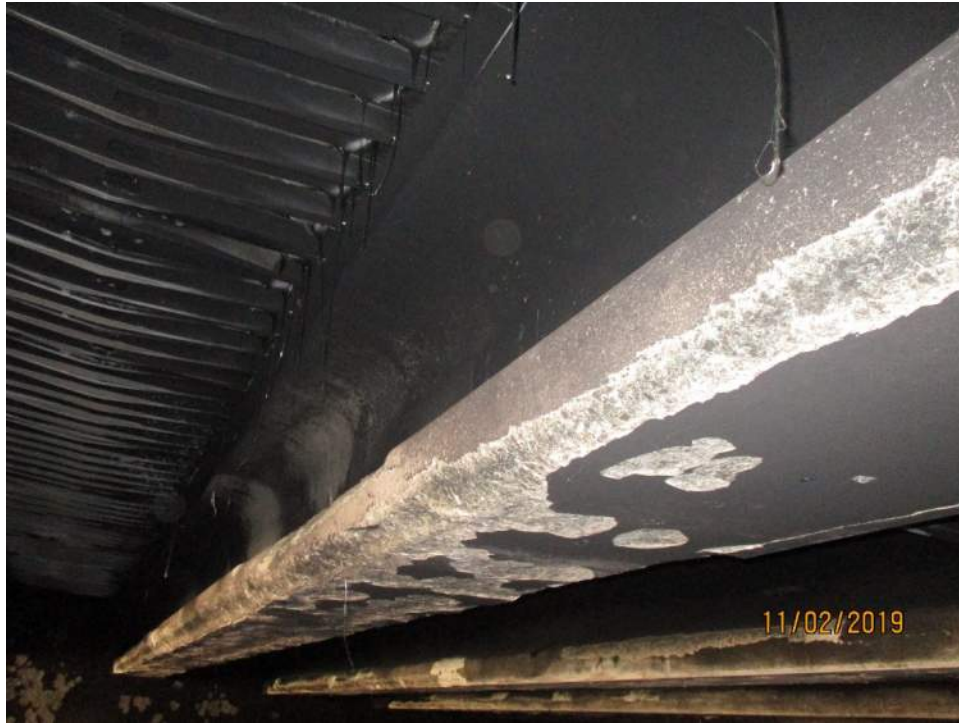
*Photo 021: Beam “F” – Bottom Flange Spalling, North Face*

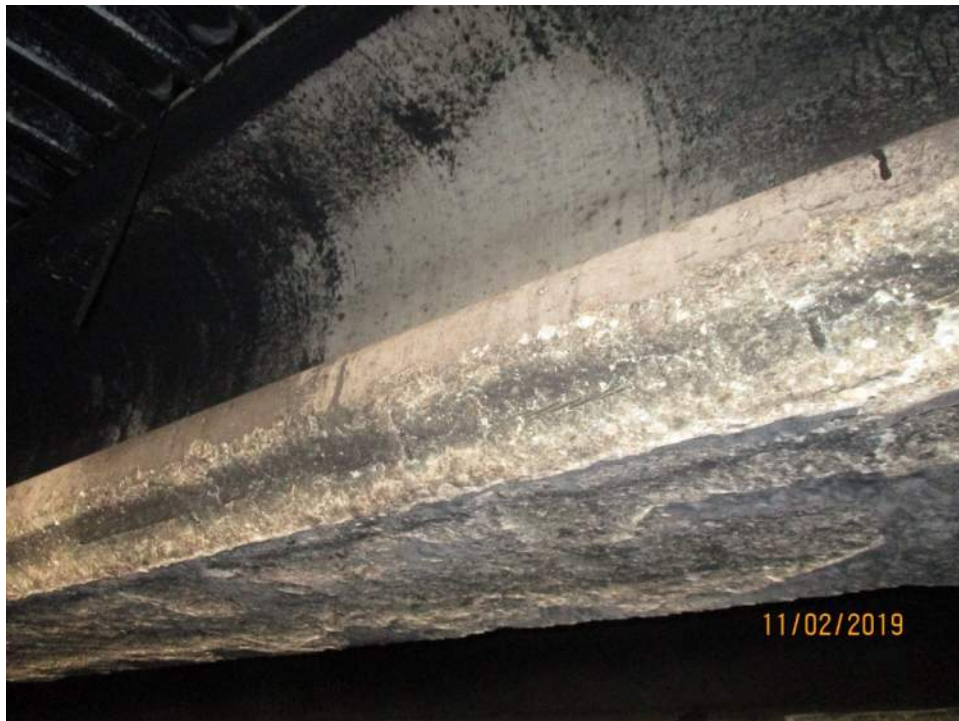
*Photo 022: Beam “F” – Bottom Flange Spall and Exposed Strand, North Face*

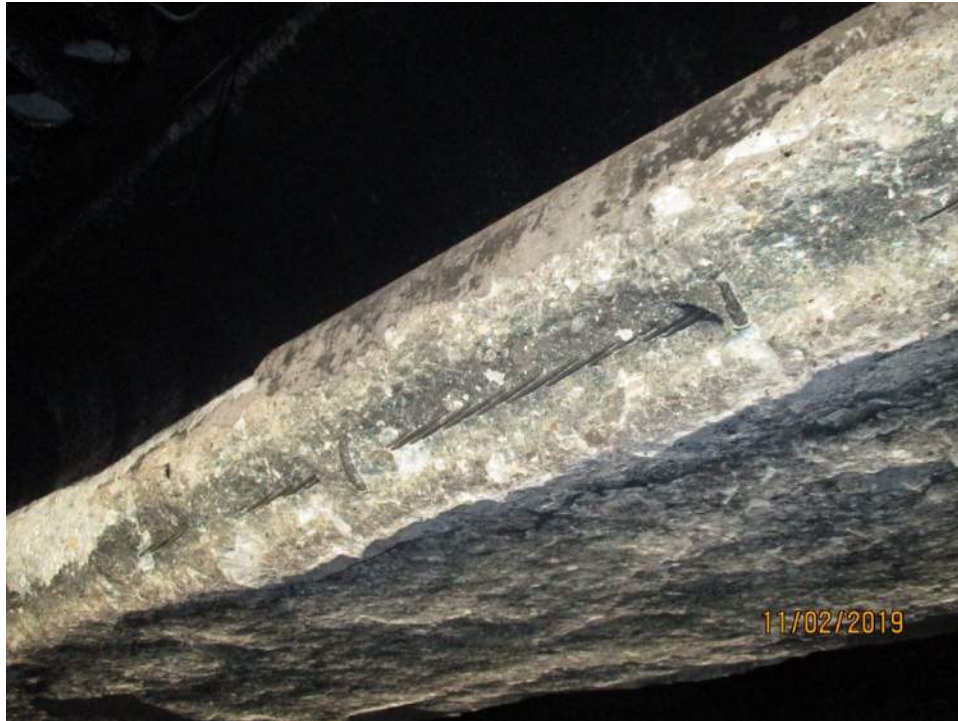
*Photo 023: Beam "F" – Exposed Strand and Stirrups, North Face*

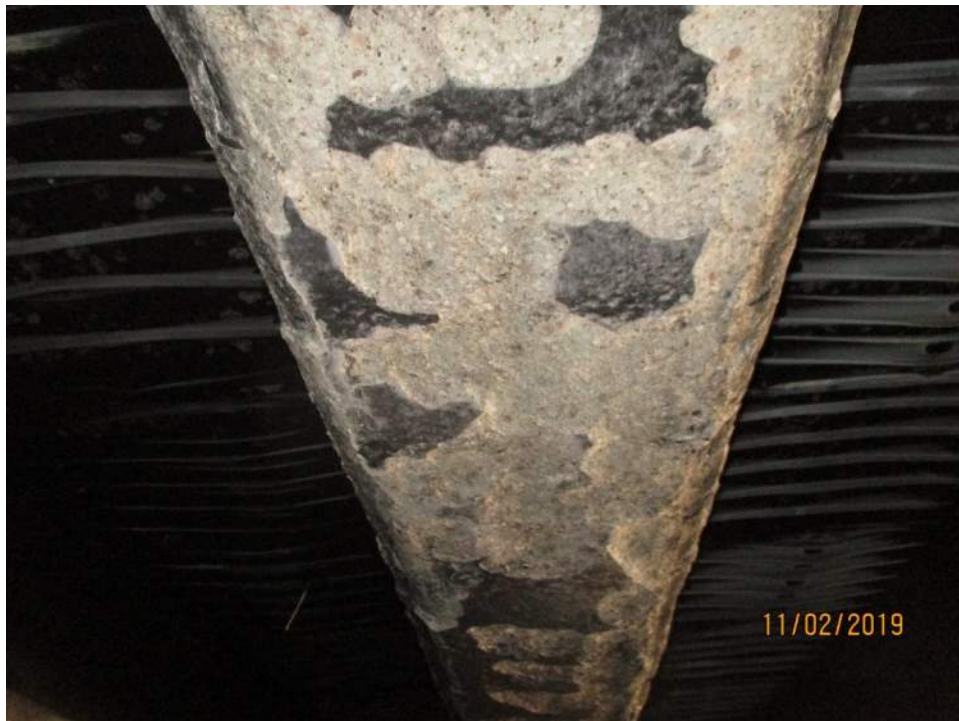
*Photo 026: Beam "F" – Bottom Flange Spalling*

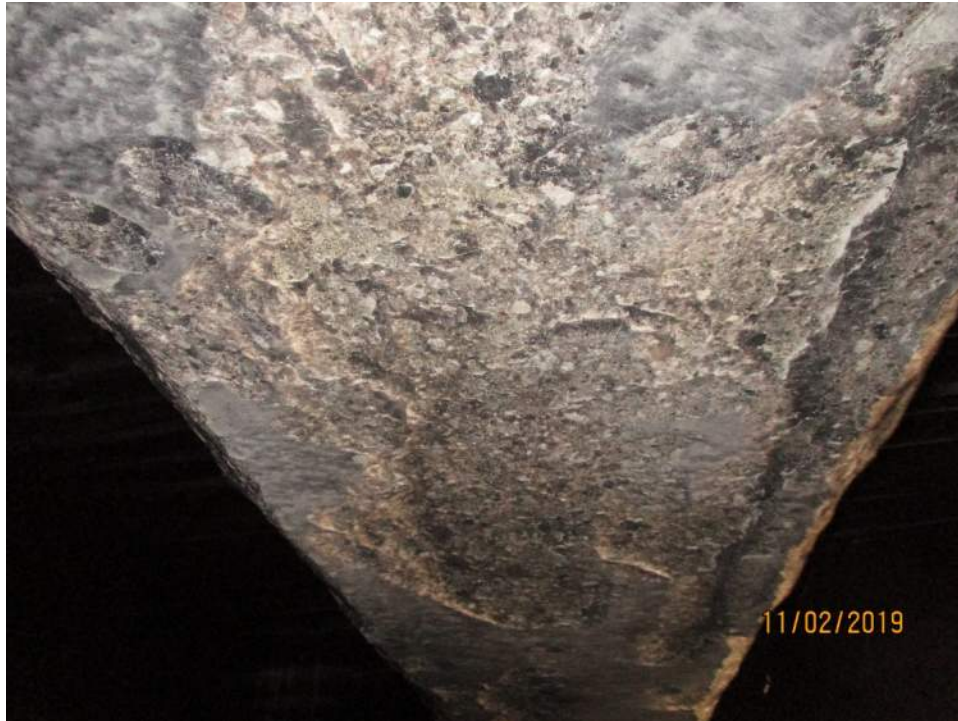
*Photo 027: Beam "F" – Bottom Flange Spalling*

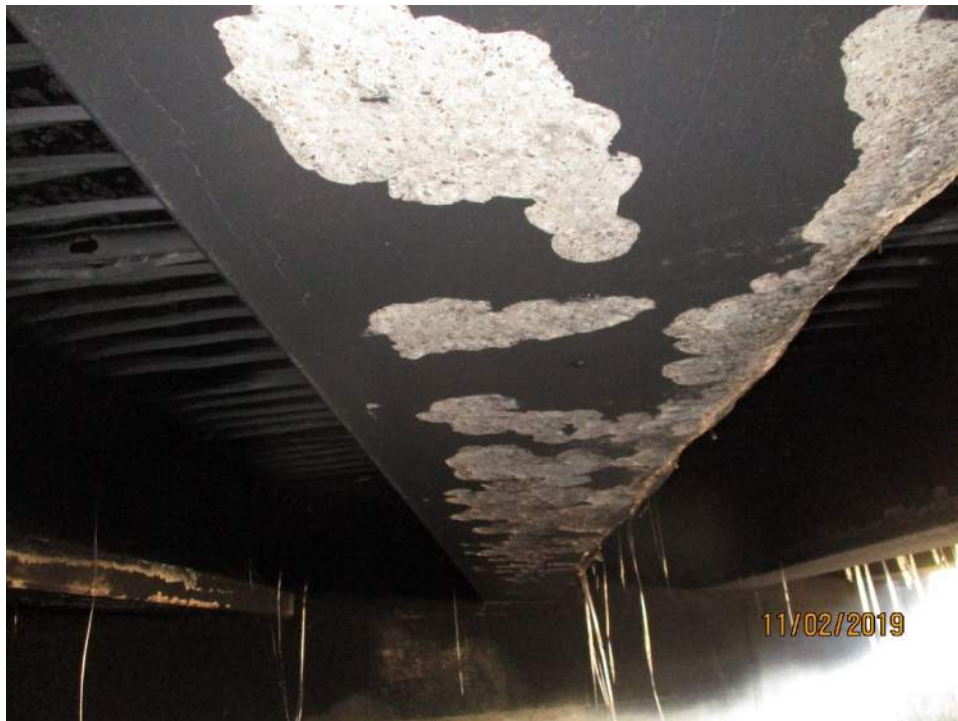
*Photo 028: Beam "F" – Bottom Flange Spalling*

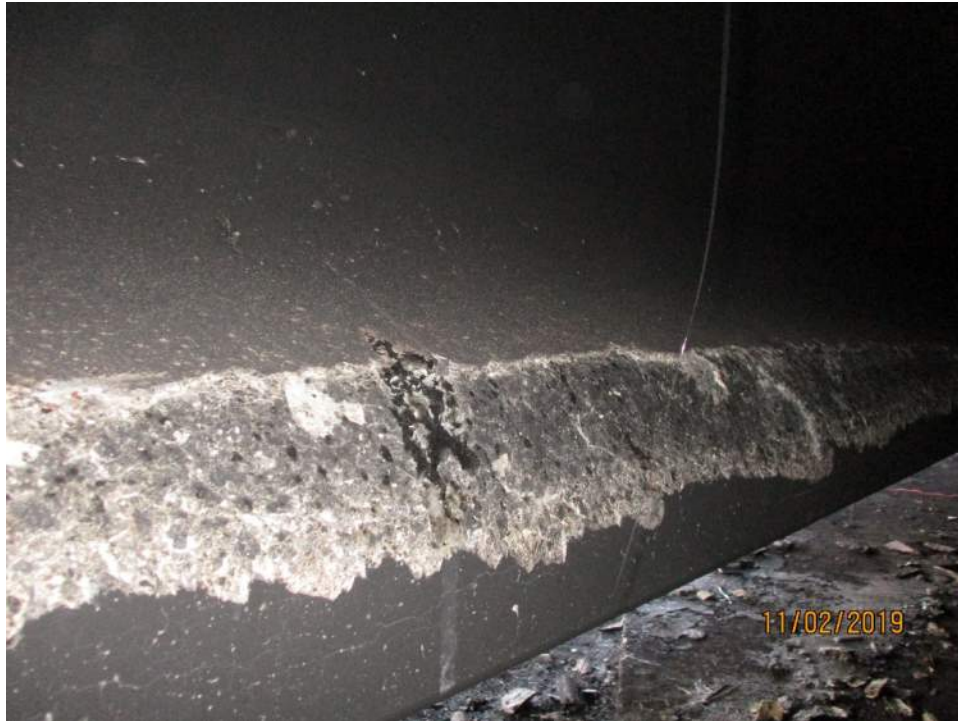
*Photo 029: Beam “F” – Bottom Flange Spalling, South Face*

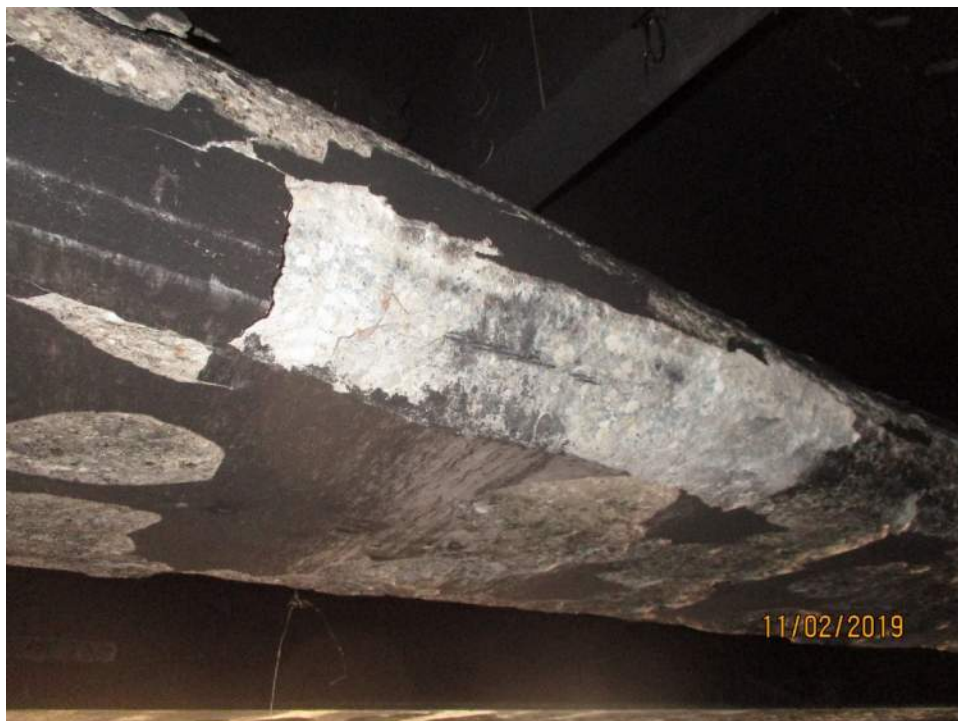
*Photo 030: Beam “F” – Bottom Flange Spalling, South Face*

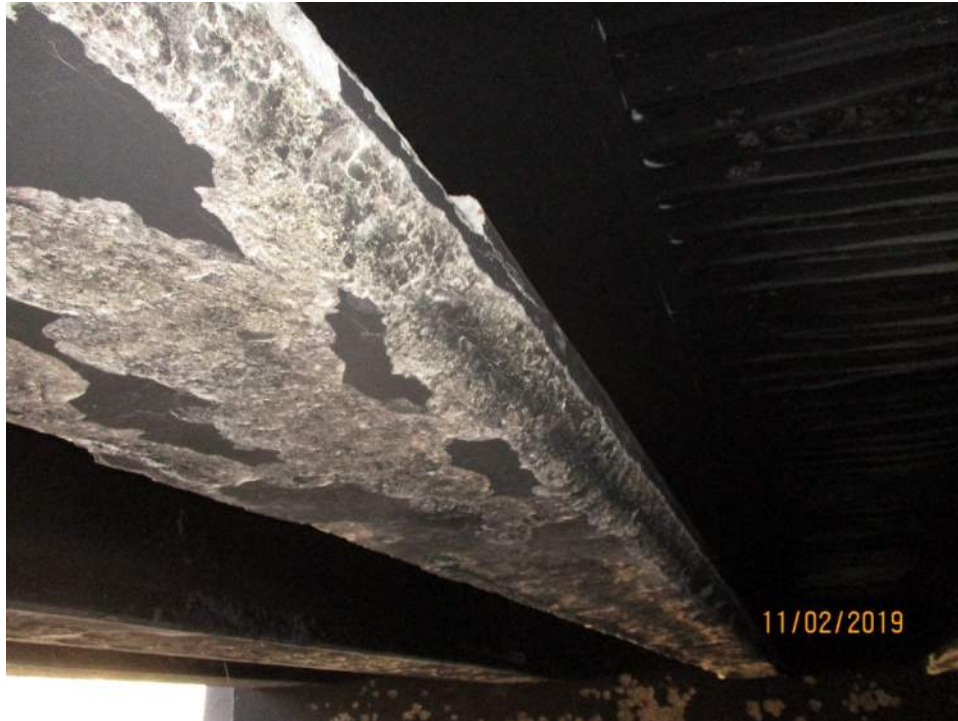
*Photo 031: Beam "F" – Bottom Flange Spalling, South Face*

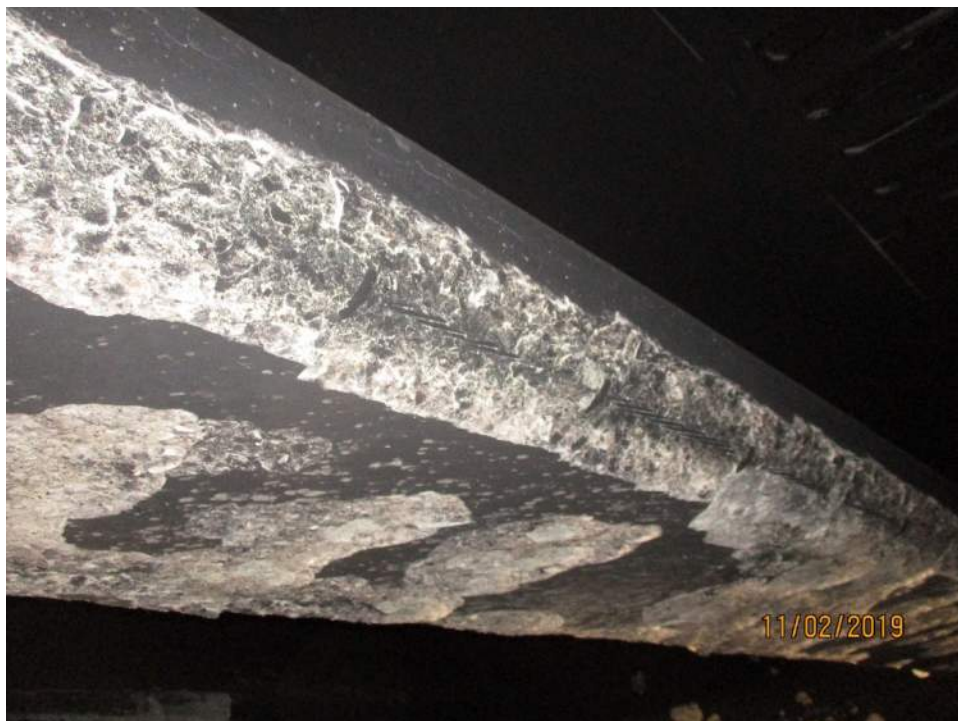
*Photo 032: Beam "F" – Exposed Strand and Stirrups, South Face*

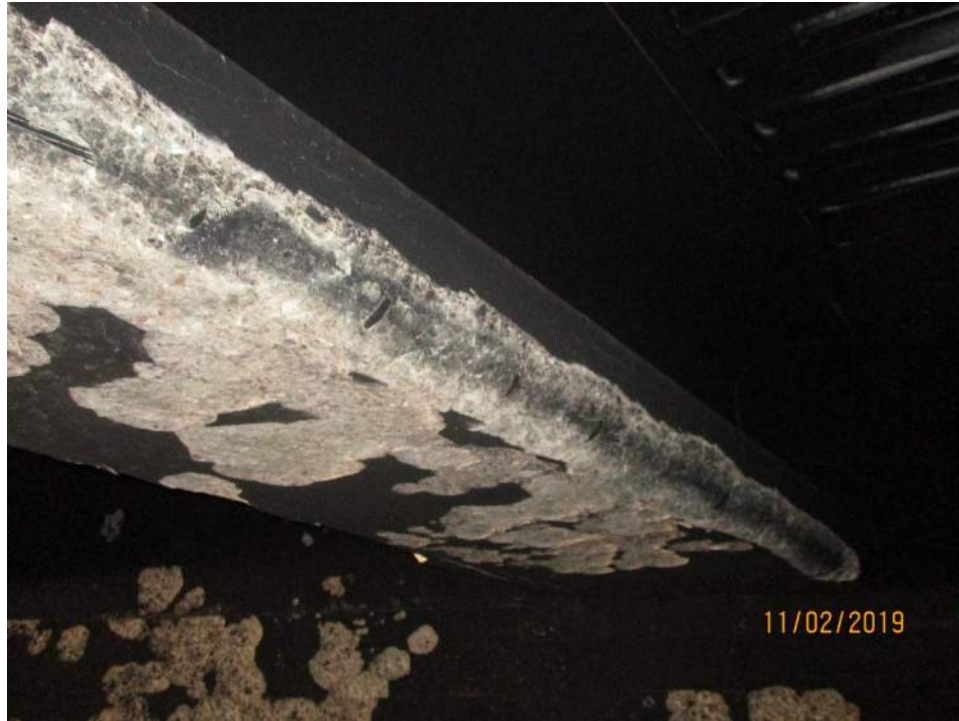
*Photo 033: Beam “F” – Bottom Flange Spalling, South Face*

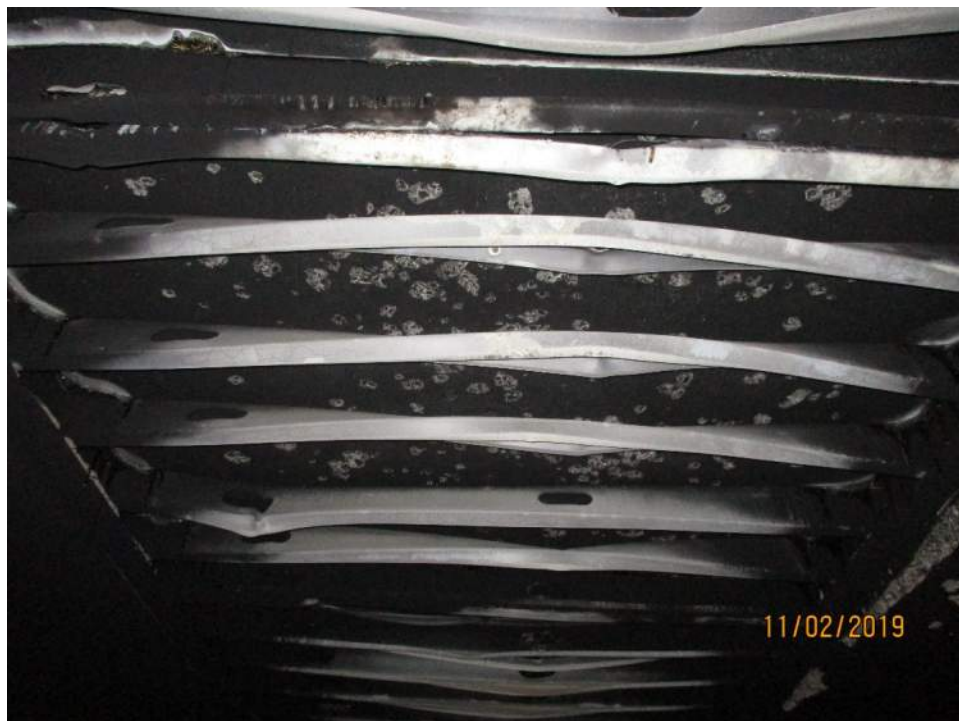
*Photo 034: Deformed Formwork supports between Beams “F” and “E”*

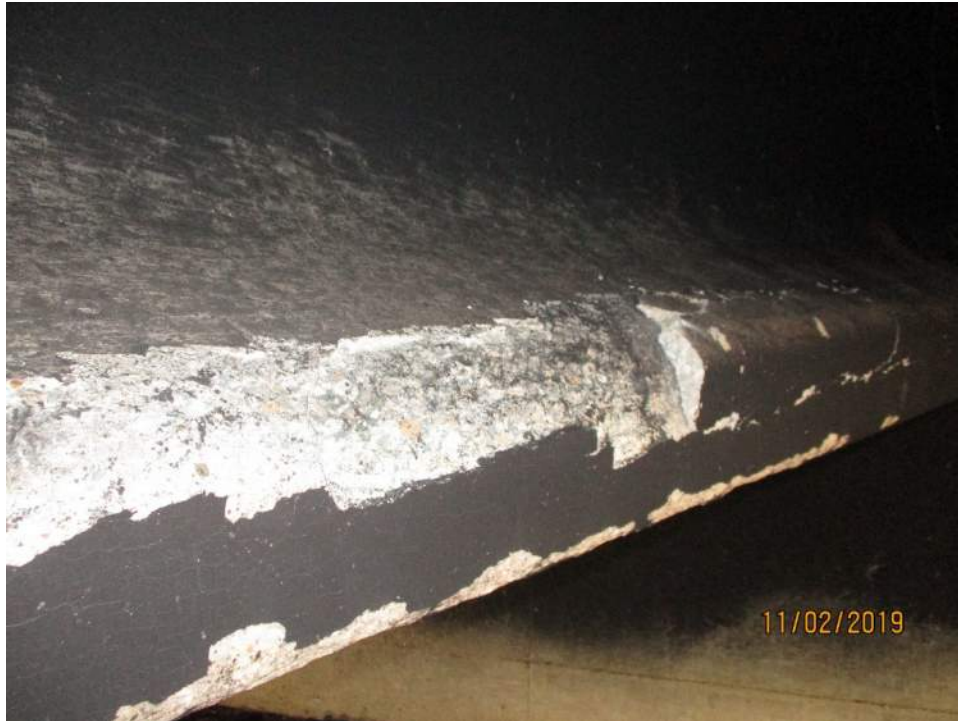
*Photo 037: Beam "E" – Bottom Flange Spalling, North Side*

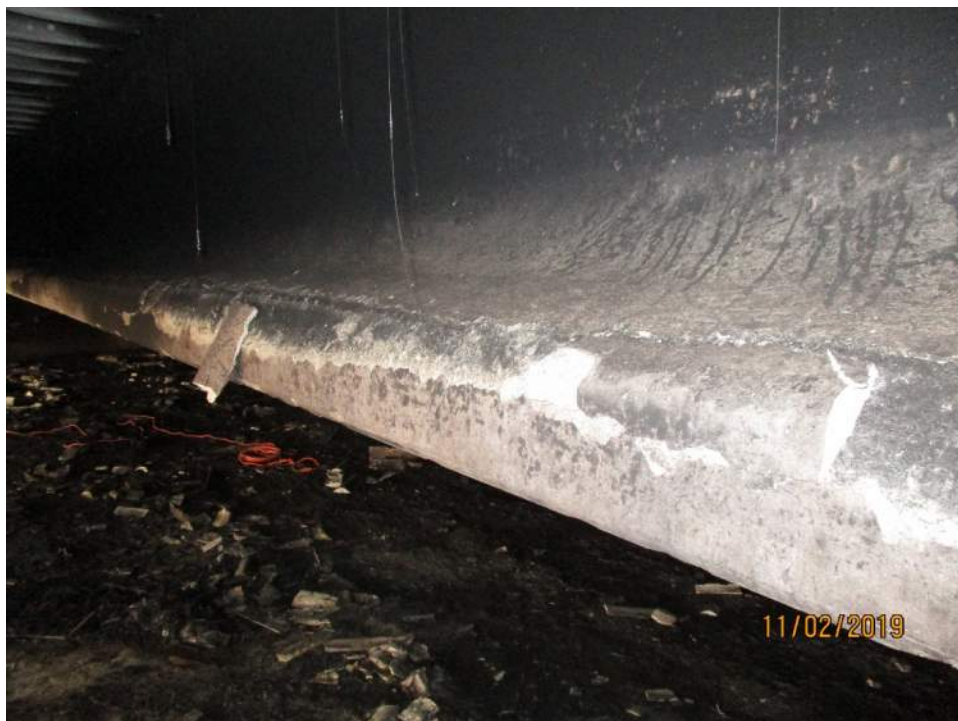
*Photo 038: Beam "E" – Bottom Flange Spalling, North Side*

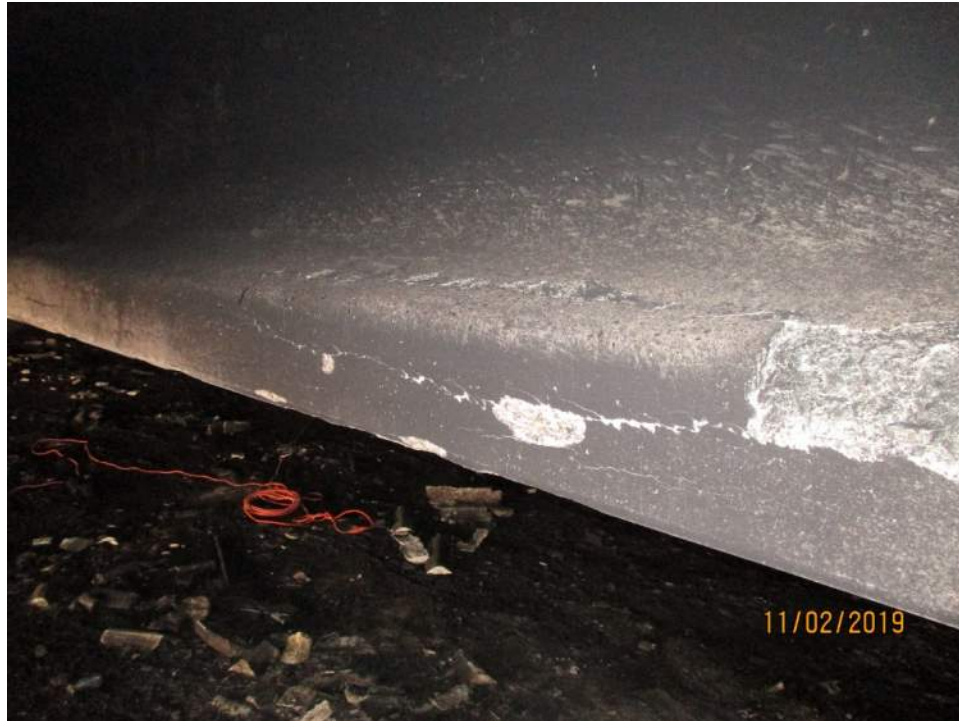
*Photo 039: Beam “E” – Bottom Flange Spalling, North Face*
